Järvenkari (Haapa Islands) MVID#1131

Location (WGS84) and date of last inspection: Lat: 60°16.483' N, Lon: 27°11.653' E // August 25, 2023

Depth & length & direction: Approximately 21m, approximately 28m and keel line approximately 160°/340V

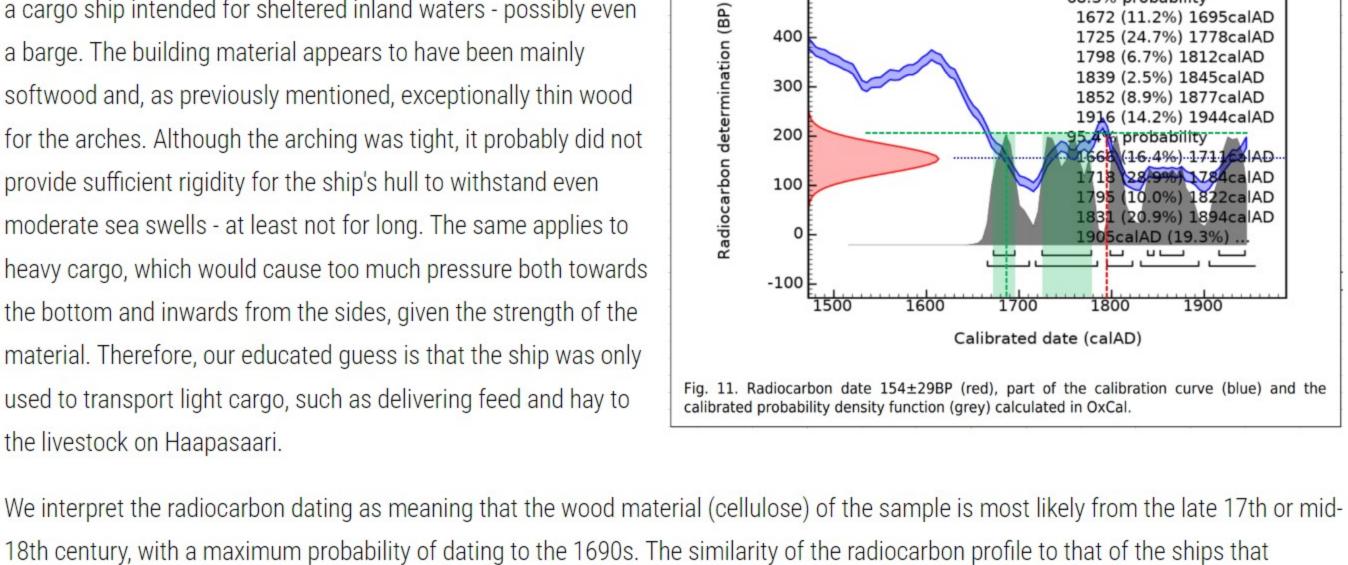
FTMC-VR52-11 R Date(154,29)

68.3% probability

participated in the Second Battle of the Swedish Straits raises the question of whether this could be a Russian cargo ship originally intended for the Neva river routes?

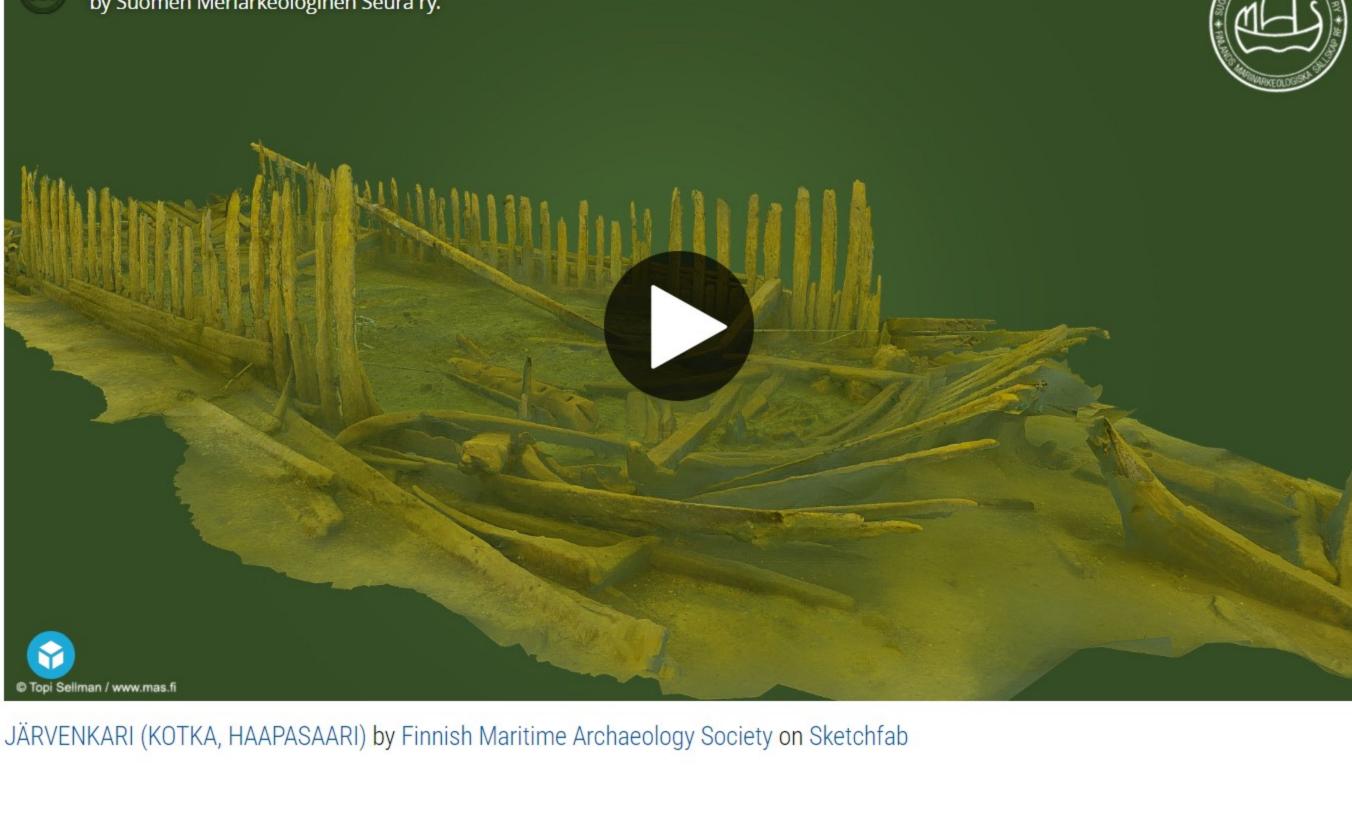
3D model of the wreck

Shipwreck Järvenkari (Haapasaaret) by Suomen Meriarkeologinen Seura ry.
