Lehmäsaari Länsiranta 2 (Kotka) MVID#1121

Location (WGS84) and date of last inspection: Lat: 60° 25.2009' N, Lon: 26° 58.8745' E // August 26, 2023

Depth & length & direction: about 8-10m, about 18m, keel line about 90°/270°

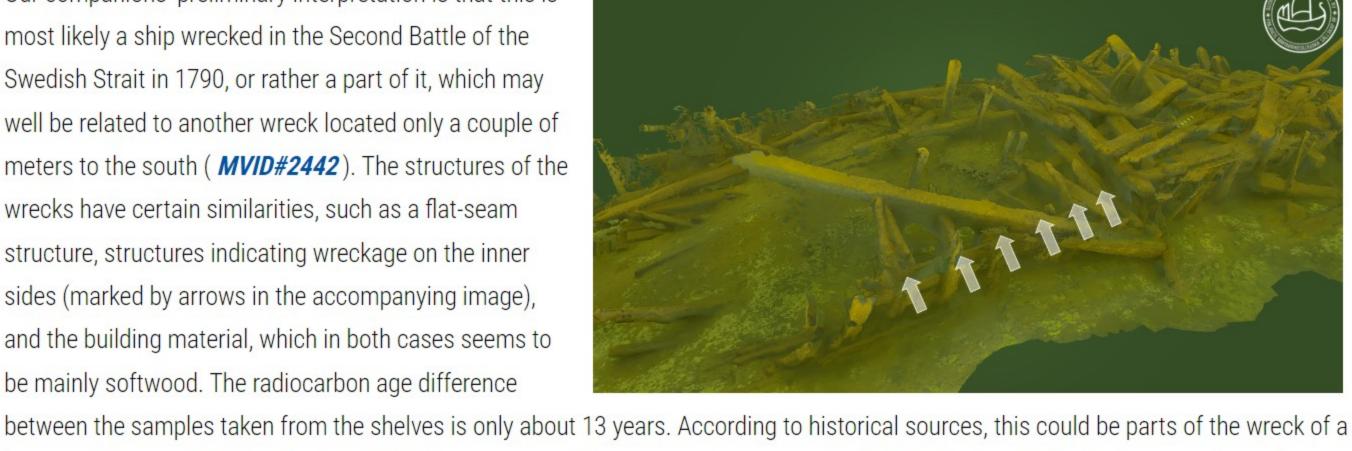
Radiocarbon determination (BP) 1720 (7.4%) 1736calAD 1803 (6.8%) 1817calAD 300 1833 (30.3%) 1891calAD 1907 (13.4%) 1936calAD 95.4% probability 200 675-(27-1%)-1744calAD 750 (4.9%) 1765 alAD)"1942calAD 100 1600 1700 1800 1900 Calibrated date (calAD) Fig. 12. Radiocarbon date 135±28BP (red), part of the calibration curve (blue) and the calibrated probability density function (grey) calculated in OxCal. dating, from a wax sample taken from the other starboard bow when viewed from the stern. Topi Sellman made a 3D model of the wreck,

which is approximately 150MB in size and contains approximately 8 million polygons. The dating sample was radiocarbon dated using the so-called With the AMS method, the results and interpretation of which can be read in the adjacent chart.

17th/18th centuries or the early 18th century, with the maximum probability falling in the 1690s.

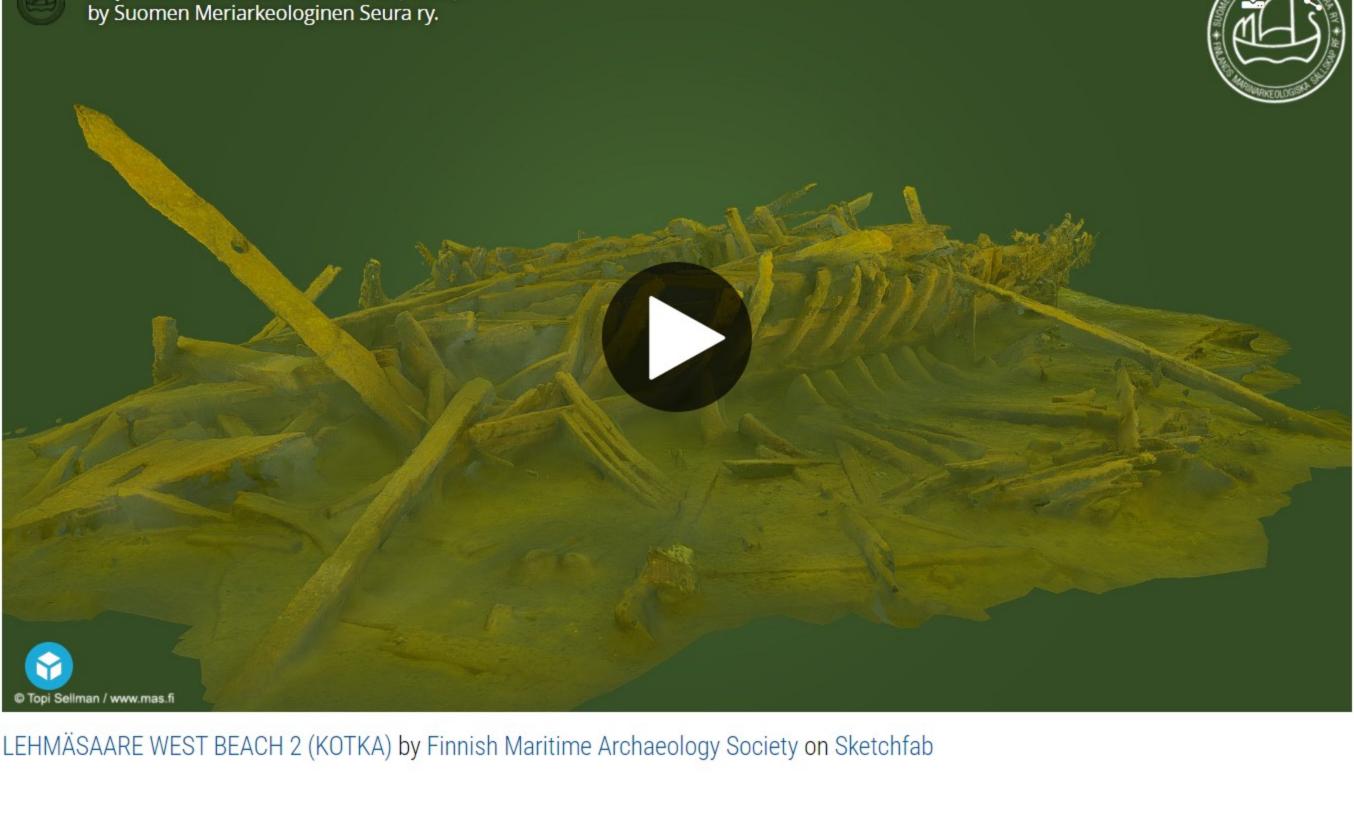
3D model of the wreck

The wreck lies at a depth of about 8-10m, almost in an east-west direction, with the end previously interpreted as the stern facing the sea, i.e. west. The wreck area is about twenty meters long, of which the wreck is about 18m. The width of the wreck is about 5-6m. As can be seen from the 3D model, the wreck is badly broken up and its other side is also largely on the bottom. There is no bow or stern frame or parts of the keel visible. A structural part rises from the so-called stern to a height of about three meters from the bottom, but it is probably too light to be a stern coaming. Ropes and jumpers have been located inside the ship, as well as some ceramics and bricks. There are structures resembling ruins on both sides.
