### South Kari (Haapa Islands) MVID#1000022856

It appears to be the remains of a merchant ship with even seams and built of oak in the 18th century. The ship was carrying a bulk cargo, of which there is plenty left.

**Location (WGS84) and date of last inspection:** Lat: 60° 16.1499'N, Lon: 27° 16.5379' E // August 25, 2023

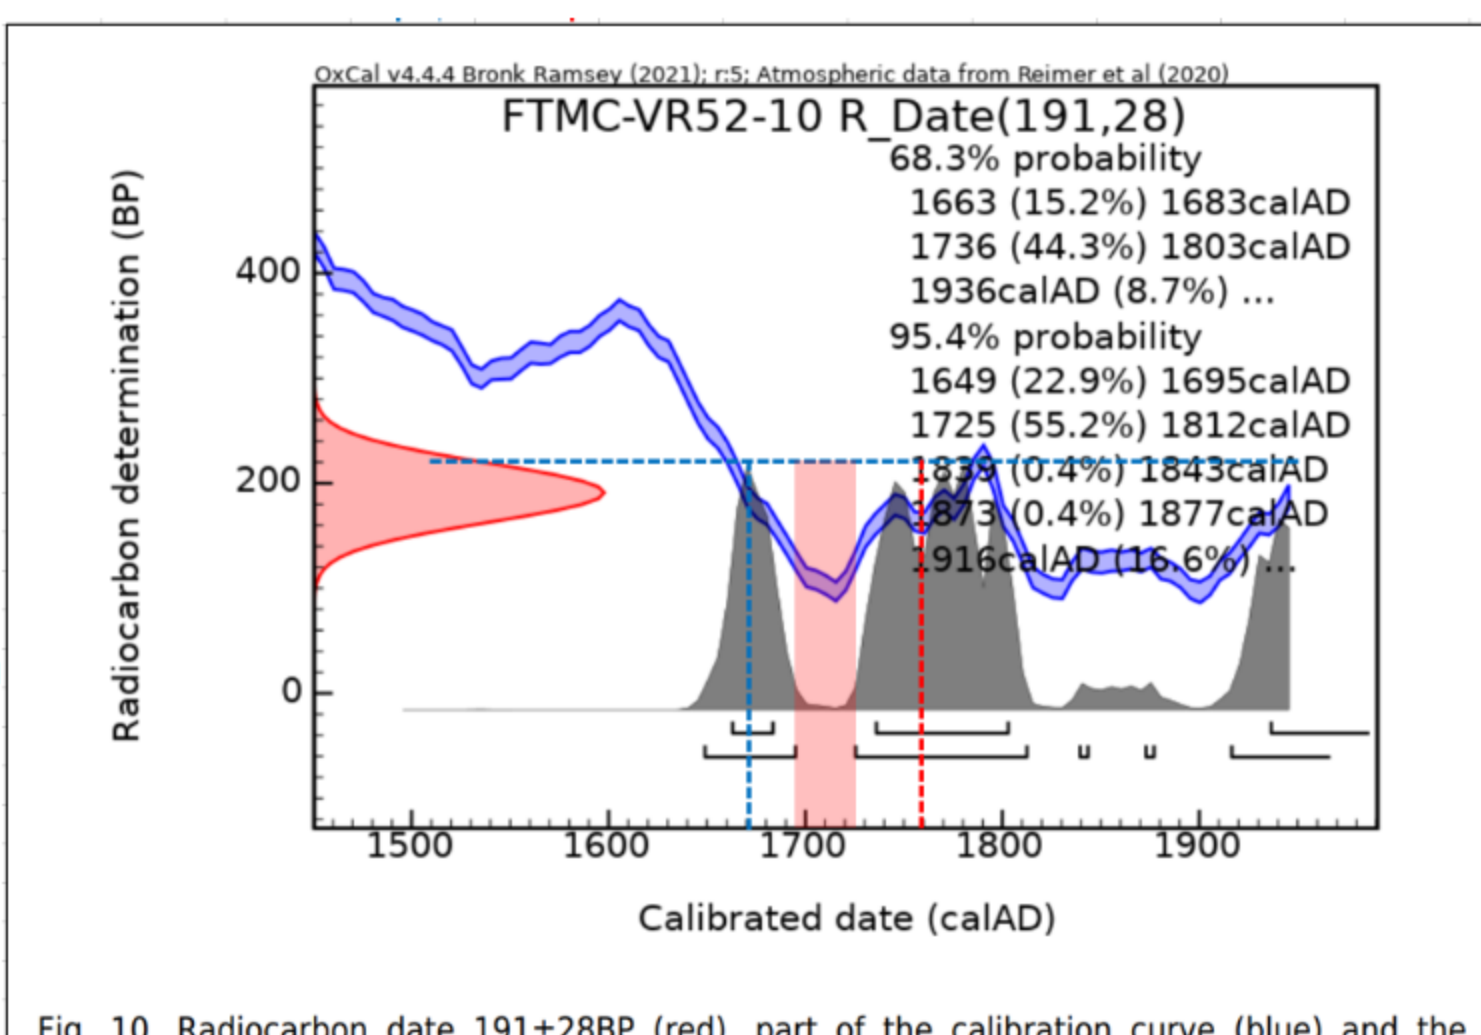
Fig. 10. Radiocarbon date 191±28BP (red), part of the calibration curve (blue) and the calibrated probability density function (grey) calculated in OxCal.

The purpose of the study was to supplement the 3D ontology of Baltic Sea wrecks collected by the Finnish Maritime Archaeological Society. The wreck was located using GPS and the coordinates of the Kyppi.fi service, which coincided with the wreck slightly to its southern end. The wreck area was explored by diving and only with non-intrusive methods. A 55 cm calibration cube and a 1 m measuring stick with a compass were placed on the wreck approximately in line with the keel line. The wreck was filmed with 4k and FHD videos. The video recording was carried out from a distance of less than a meter. In addition, artifacts in the wreck were photographed with high-resolution photographs. The quality of the wood material was observed extensively on the wreck and, for timing, from a stream sample taken from the third port bow when viewed from the stern. Due to the dead algae floating in the water, no material suitable for modeling was captured from the wreck. All source materials can be found in the "massdownload" link above. from the wreck site directory. The dating sample was subjected to radiocarbon dating using the so-called AMS method, the results and interpretation of which can be read in the adjacent diagram.

Our companions' preliminary interpretation is that it is a merchant ship with straight seams and mainly made of oak. The accompanying AMS radiocarbon dating strongly suggests that the wooden material was felled in the 18th century, although the end of the 17th century is also possible. However, the machining marks on the anchor windlass, the attachment and the metal-reinforced ratchet suggest that the ship is from the 18th century and most likely from the latter or early part of it. The ship was considerably more solidly constructed than the so-called Dutch-type ships of the same period, which could indicate a ship from further across the Atlantic, for example from England. The wreck itself did not contain any exceptional structural components or artifacts, but its bulk cargo is interesting because it may reveal something new about our foreign trade. The goal of the next expedition should definitely be to take a cargo sample and have it examined. Naturally, 3D modeling is also worth trying, if visibility allows.
