Bastuhamn (Pellinki) MVID#1032

The Bastuhamn wreck appears to have been a sailing ship built of softwood, with a rabbeted pattern throughout, which was very wide and plump amidships, but whose bow and stern narrowed quite sharply, at least near the waterline. The bow and stern were straight and the ship apparently did not have much deck, as no knees have been identified from the wreck. The ship's bow apparently had a hearth made of slate. The wood in the wreck has been tentatively dated to the 17th century.

Location (WGS84) and date of last inspection: Lat: 60° 13.7434' N, Lon: 25° 49.8335' E // March 6, 2024

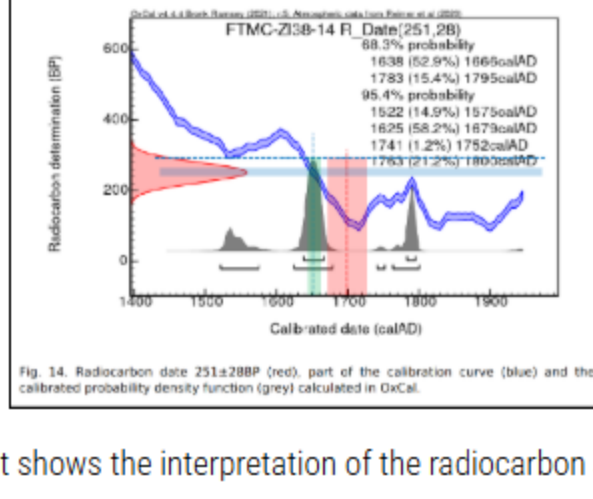
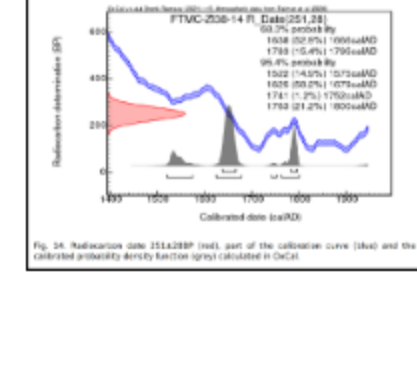
A sample of the stream taken from the wreck was radiocarbon dated at the Vilnius University Radiocarbon Laboratory, which gave a radiocarbon age of 251±28BP for the wood sample. When calibrated and interpreted, the result places the wood sample in the mid-17th century, although there is a small possibility that the sample is a hundred years older or almost a hundred and fifty years younger. The dating results are always probabilities. The larger of the images on the right shows the interpretation of the radiocarbon age calibration to normal calendar years, and the smaller image allows you to download the original laboratory result. The residual carbon amounts and pMC measurements can also be found on the MAS research data portal.

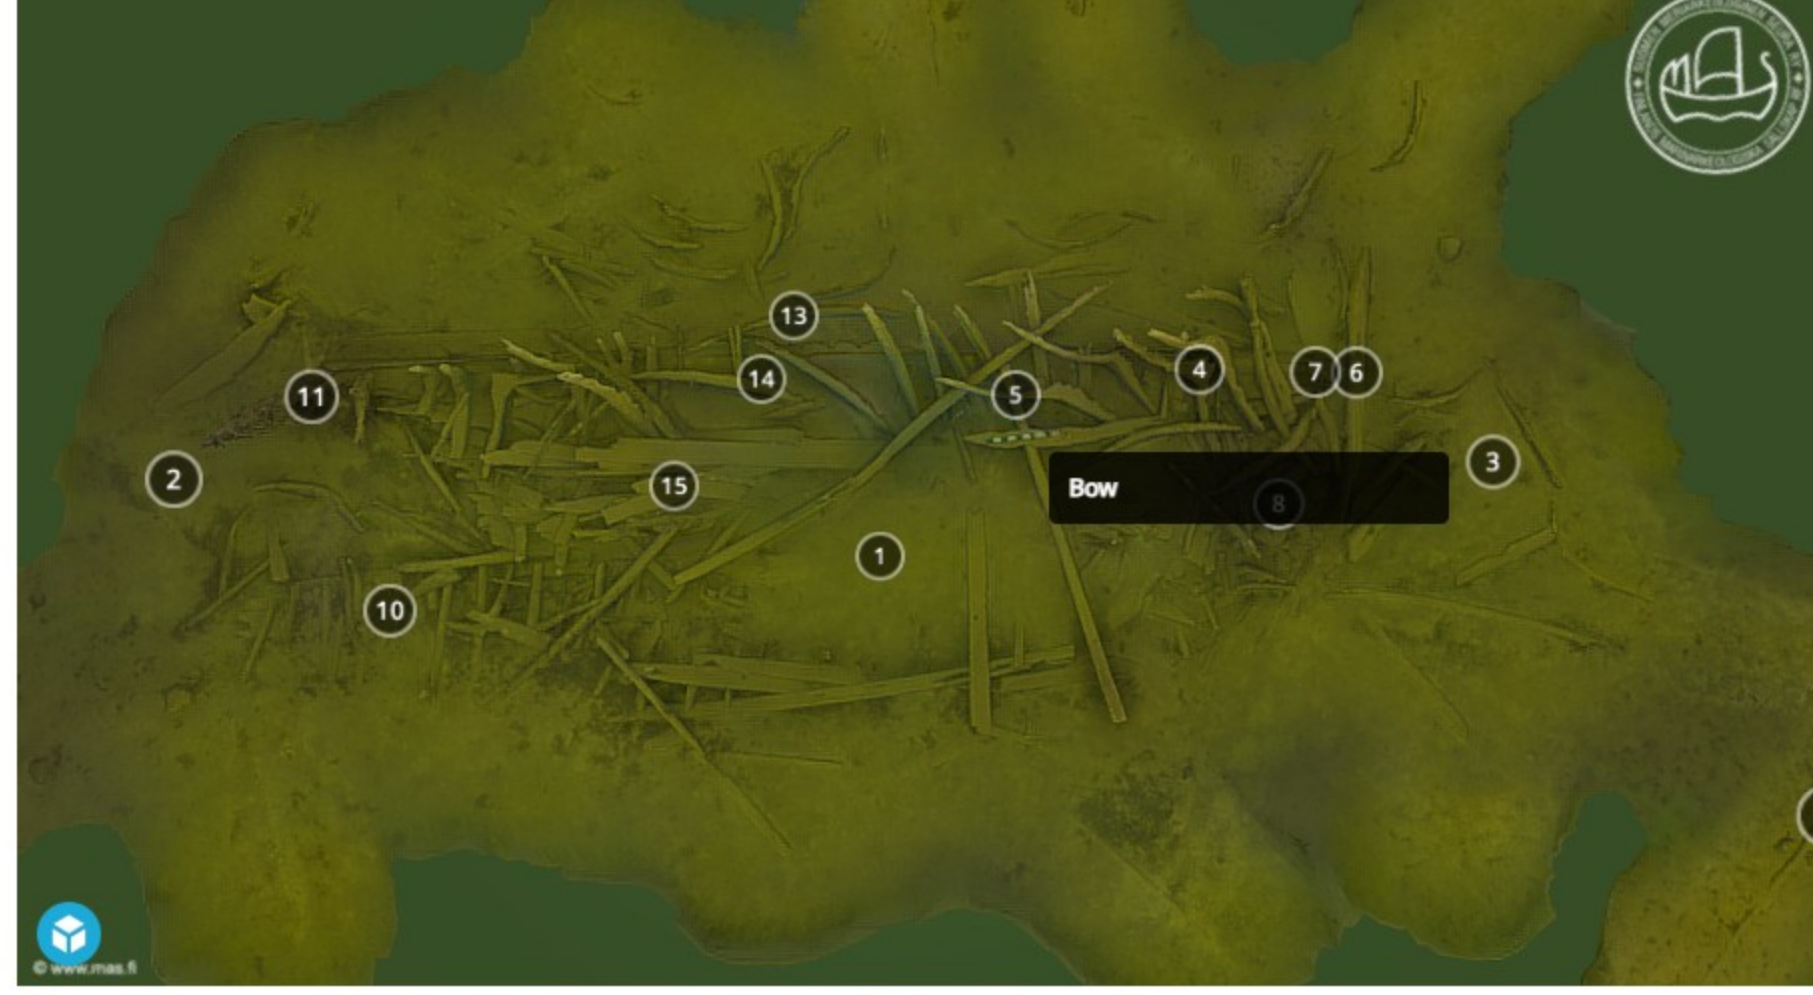
3D model of the wreck

Shipwreck Bastuhamn (Pellinki) by Finnish Maritime Archaeology Society on Sketchfab
